BED SIDE FLANGE COVERS FLAT AND ANGLED STYLES

#@\$!*@#\$\$% INSTRUCTIONS
MID FIFTY F-100 PARTS 1-800-252-1956

INST-90207

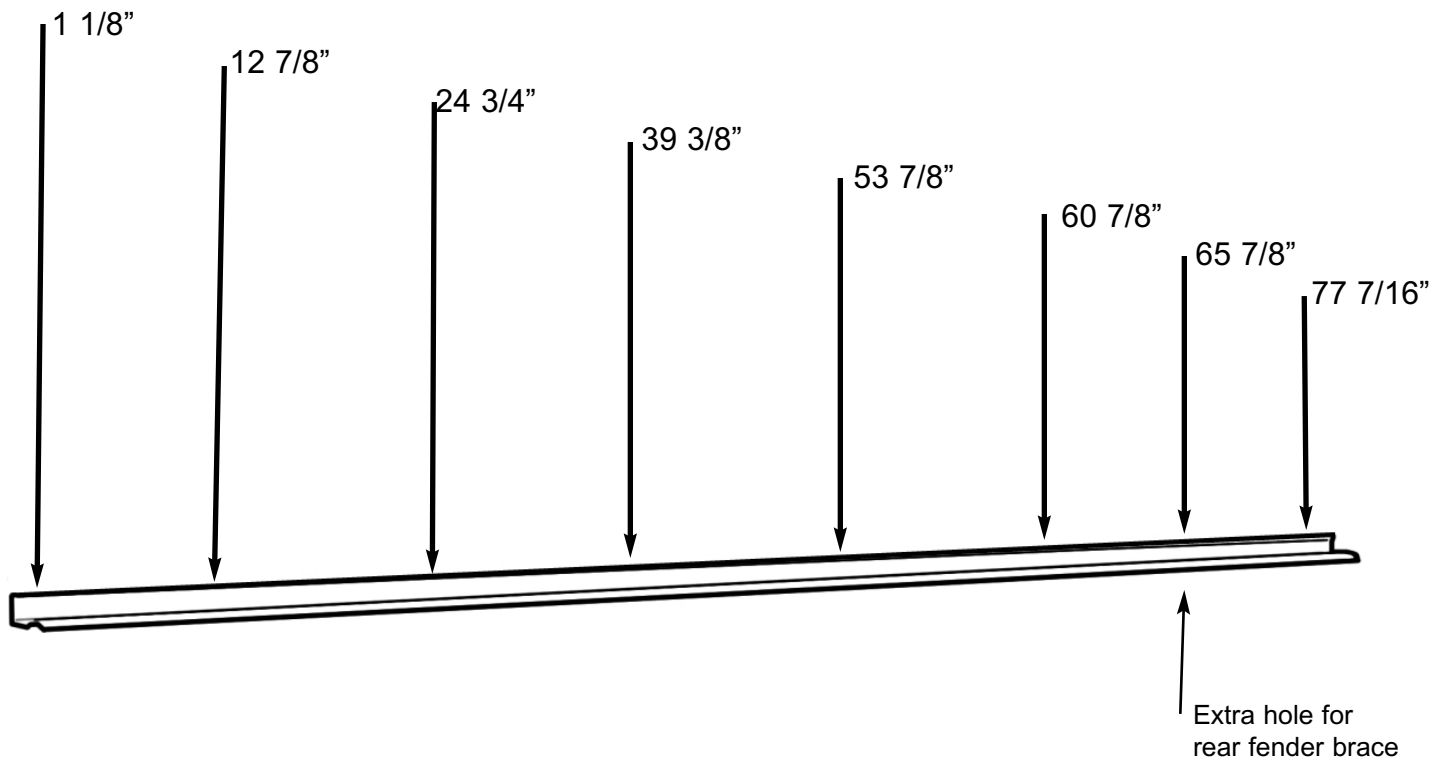
Using a standard tape measure, note this is NOT the specs used to set up hole punching, this is a drawing so the holes can be checked "in the field" if, for some reason, the strips are not lining up with bed sides. Bedsides have been produced by a half dozen companies as well as a couple versions from Ford over the years. These strips are punched for the stock bed side which covers most of today's reproductions. The Flange Covers are not an original item, we made them years ago to cover the flange for a couple reasons. One, it makes the whole bed seem more symmetrical as the floor strips are all same finish this way. Two, the angled ones cover the flange and up the bedside an inch. Bedsides will often have rust damage, paint chips, drips, etc. along that 90 degree bend. Flanges straighten out and clean up the whole thing quick and easy.

There are 3 holes close together toward the tailgate end. The "off" hole is a stock hole in the bedside flange and is where the rear fender brace bolt goes.

Flange covers without the angle have a hole at the tailgate end which must be drilled in the bed flange, because these do not go to the end of the side, not intended to go over or under the end cap.

← FRONT OF TRUCK
