REAR SPRING FORWARD HANGER

#@\$!@#\$% INSTRUCTIONS
MID FIFTY F-100 PARTS 1-800-252-1956

2810
TAAA 5785

REAR SPRING FORWARD HANGERS

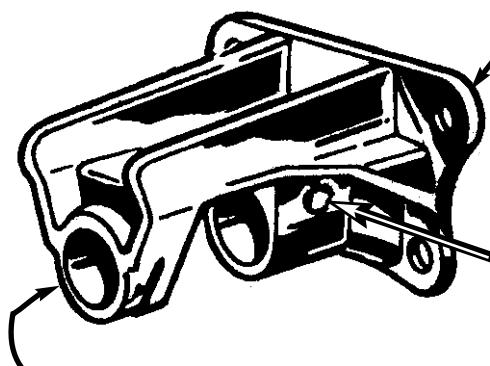
Hangers produced in recent years have some flaws. Unfortunately they are the only ones available and no correct remakes seem to be on the horizon. Here are some steps to make these work.

Spring pin may set deep
May need long zerk.

Frame holes may not line up. Original hanger was riveted to frame. You may need to redrill frame to line this one up. Most of you will be redrilling frame anyway in order to flip hanger upside down when using reversed eye springs and/or to set hanger as high as possible. Higher the hanger, lower the truck. Bolts for mounting #84438

Locking pin hole is wrong:

Should have been tapered for pin, may be too large or too small.
To fix: Ream out to fit locking pin, make sure pin does NOT go all the way through. Or use 2" long x 7/16" grade 8 bolts in place of the locking pin. Our #82811

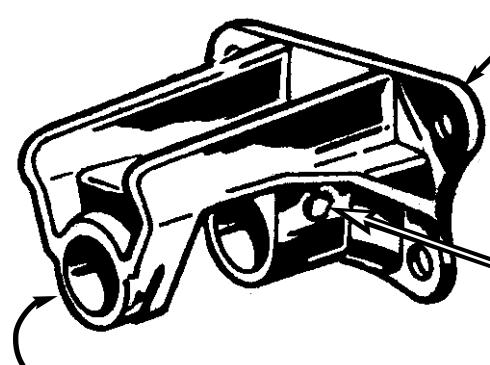
Hangers produced in recent years have some flaws. Unfortunately they are the only ones available and no correct remakes seem to be on the horizon. Here are some steps to make these work.

Spring pin may set deep
May need long zerk.

Frame holes may not line up. Original hanger was riveted to frame. You may need to redrill frame to line this one up. Most of you will be redrilling frame anyway in order to flip hanger upside down when using reversed eye springs and/or to set hanger as high as possible. Higher the hanger, lower the truck. Bolts for mounting #84438

Locking pin hole is wrong:

Should have been tapered for pin, may be too large or too small.
To fix: Ream out to fit locking pin, make sure pin does NOT go all the way through. Or use 2" long x 7/16" grade 8 bolts in place of the locking pin. Our #82811
