1956 Wiper Linkage & Parking

INST-3000-56

1956 WIPER & LINKAGE ASSEMBLY

PARKING INSTRUCTIONS

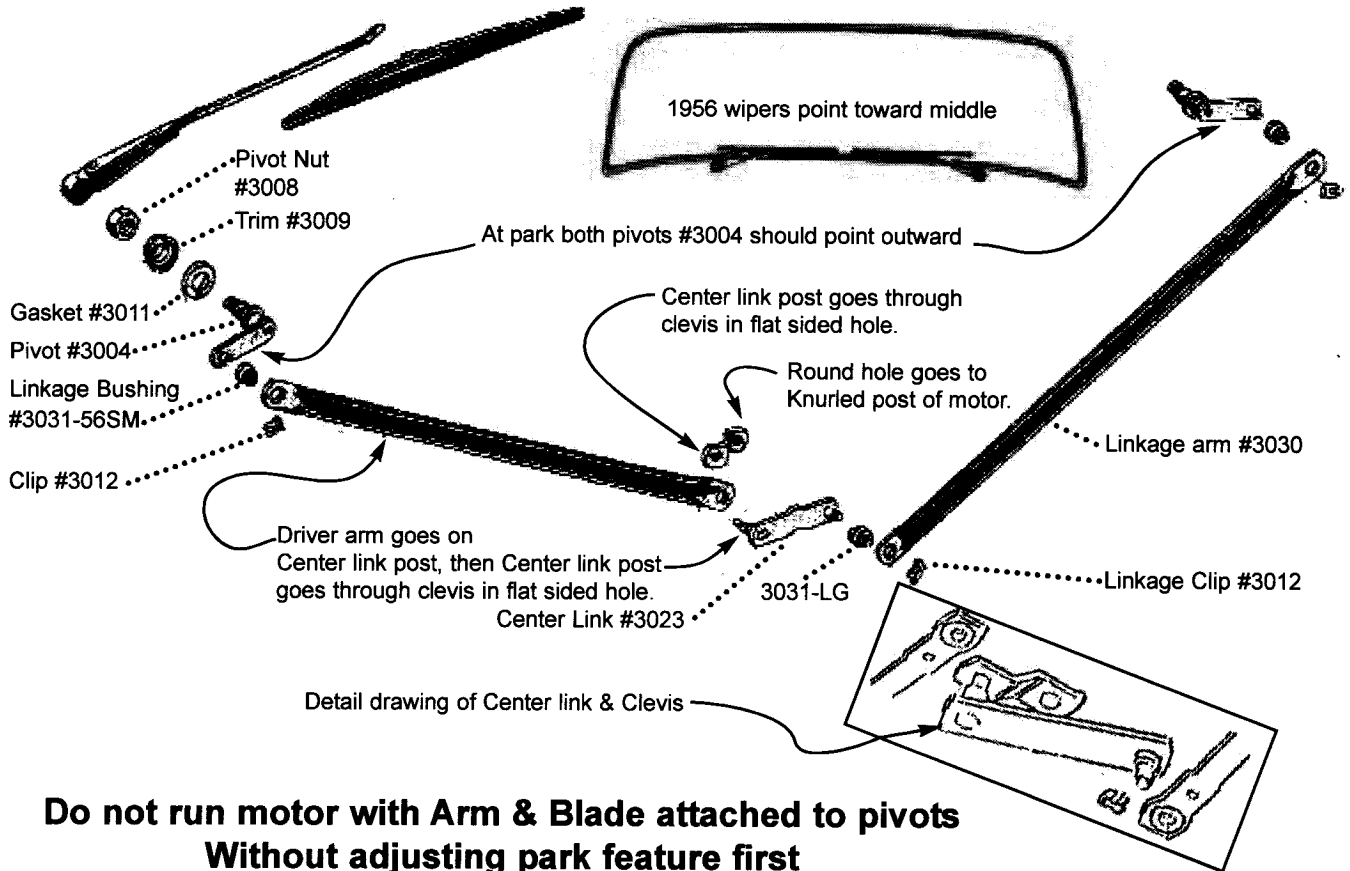
Do not run motor with Arm & Blade attached to pivots Without adjusting park feature first

Wiper arms may hit cowl, damaging paint, arms and motor.
Determine proper park location: Running motor, Without Arm & Blade Assembly attached.
Stop, let park,
Mark location on pivot, test a few times, make sure it is parking in same place each time.
Make sure it is not going down before sweeping upward as shown to left.
When you are positive both pivots are turning correctly.
Then attach blade & arm assembly.

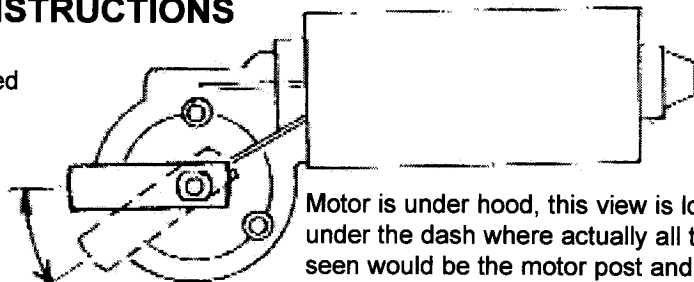
Clevis can be adjusted by lifting away from motor knurls and turning slightly.

Motor is under hood, this view is looking under the dash where actually all that is seen would be the motor post and clevis.
